**ecology and environment, inc.**

June 30, 1997

Subject: **Phoenix Hydrocarbons, Maricopa County, Arizona** (Latitude: 33° 30' 39"
Longitude: 112° 5' 0")

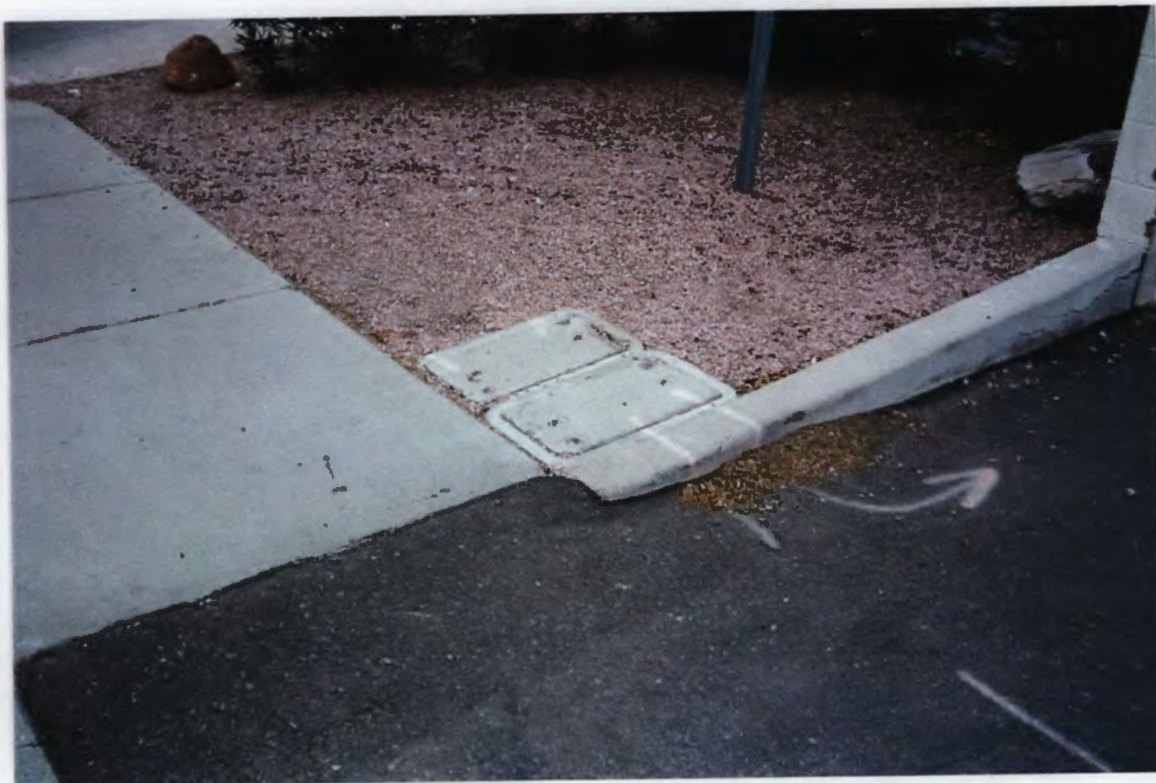
(9) Signal Box, 100' South of Camelback, East Side of 1st (Southern One)	10:10	0	0	20.7	2.50	0.30
(10) Signal Box, North of Residential Driveway on 1st (Northern One)	10:14	0	0	20.7	2.60	0.24

(11) Signal Box, North of Residential Driveway on 1st (Southern One)	10:16	0	0	20.7	2.45	0.15
(12) Water Box in Driveway/Alley	10:19	0	0	20.4	2.6	2.6

Photo 2: Traffic signal boxes, north of residential driveway (locations 10 and 11)

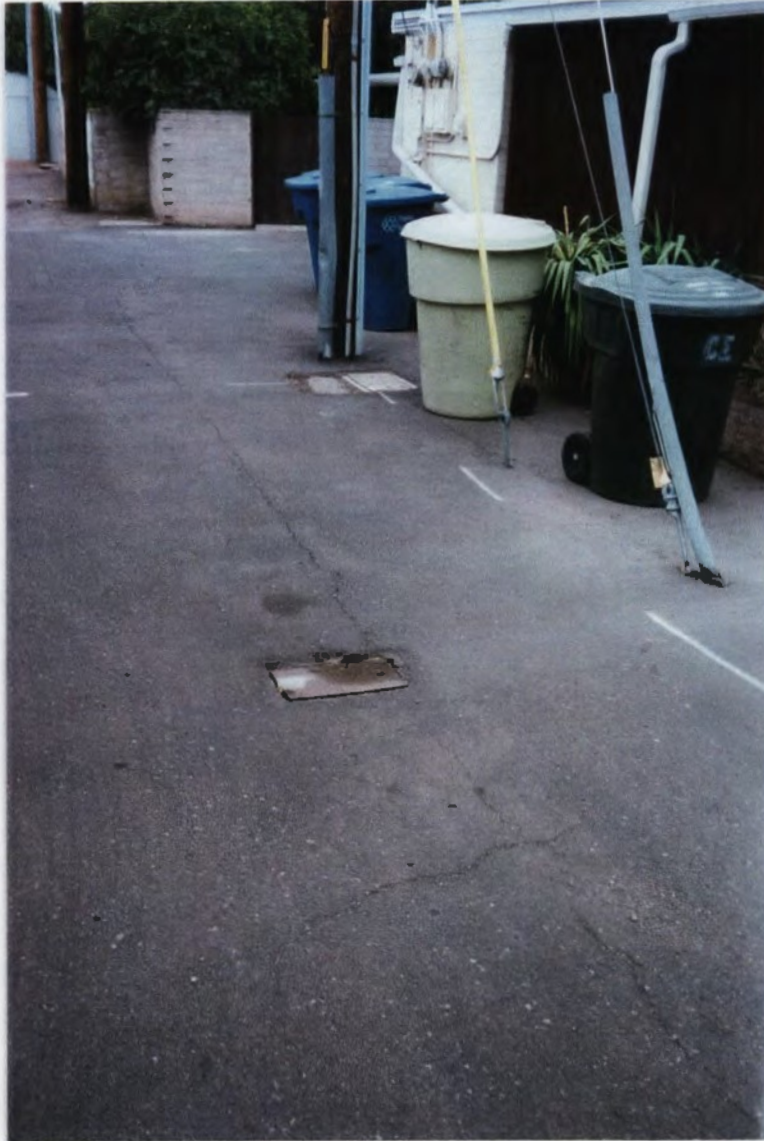
Photo 3: Water service box in alley (location 12)

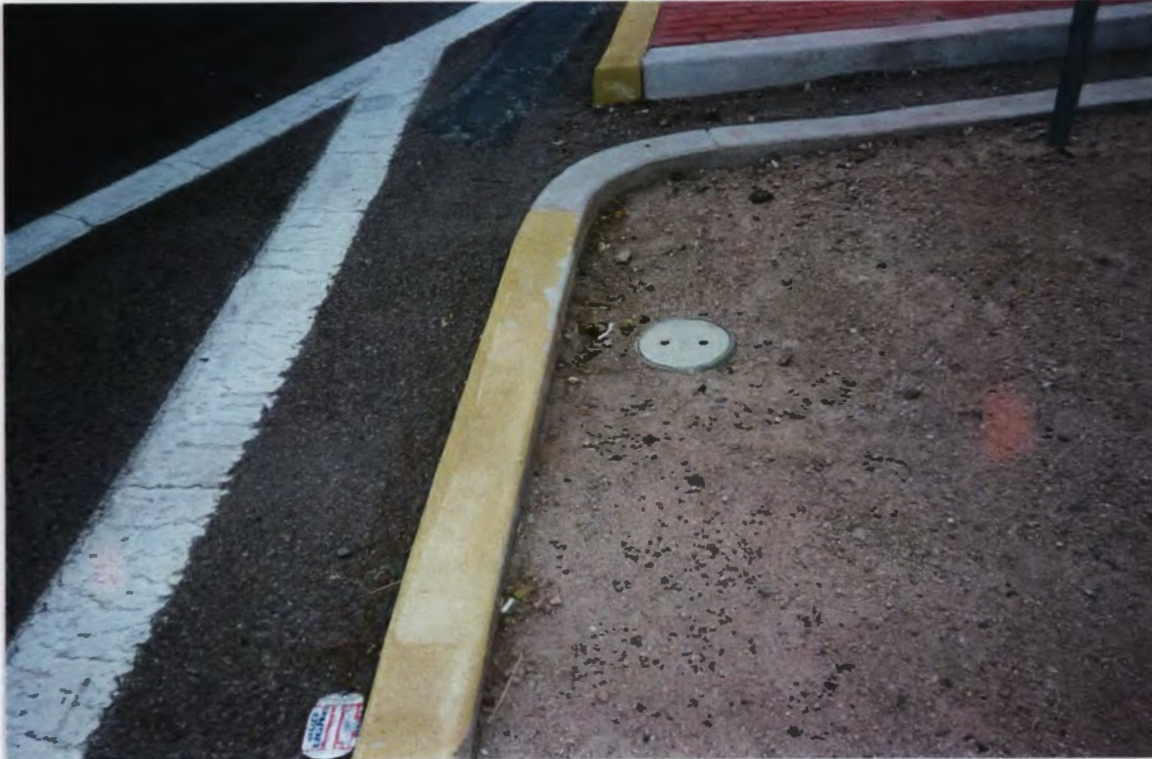
(16) Water Hole, East Side of 1st on Sidewalk, Near Intersection with Mariposa, 1.5' BGS	10:30	0	0	20.8	2.70	0.30
(17) Sprinkler Valve Box, On Island at Mariposa and 1st, Plastic	10:35	4	0	20.7	3.10	927

Photo 4: Sprinkler control on island, at intersection of 1st and Maricopa (location 17)

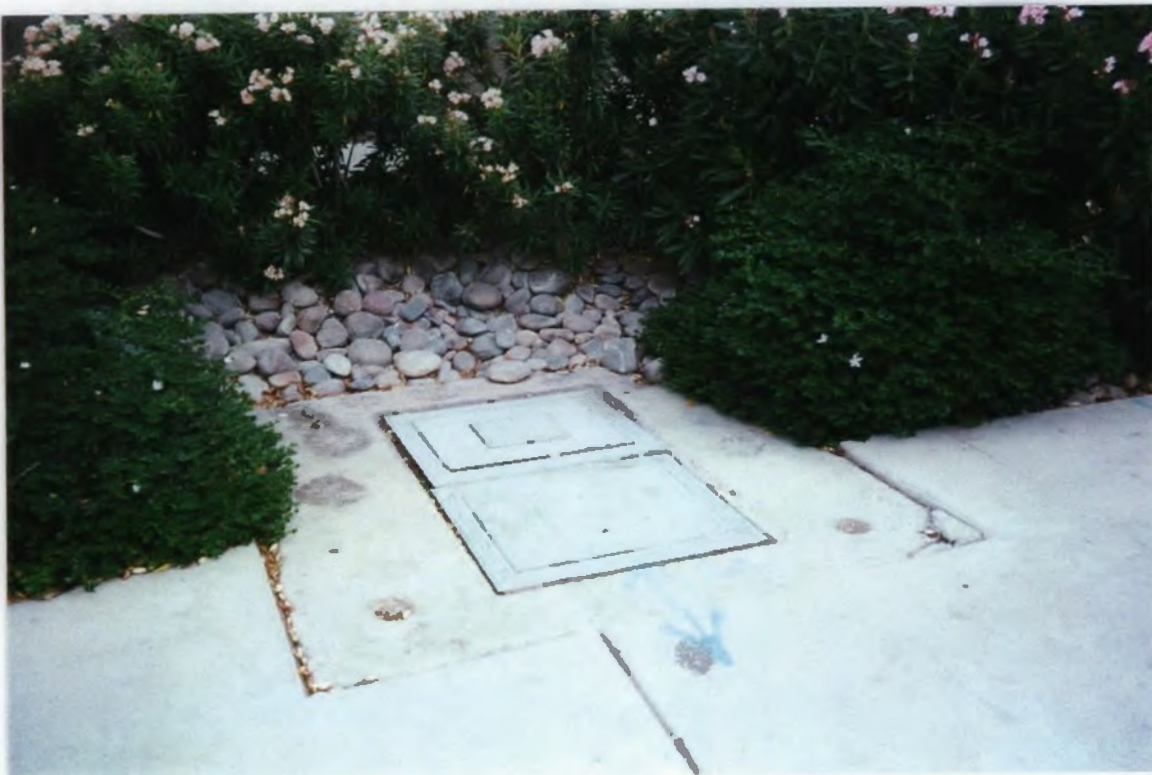
(42) APS Electrical Box, West of One Camelback, On East Side of Central, Near Traffic Light	12:37	0	0	20.8	4.60	0.38
(43) Water Box, 20' West of 1st Street, North of One Camelback, South Side of Camelback	12:45	0	0	21.0	4.32	0.15

(44) Water Box, 20' West of 1st Street, North of One Camelback, South Side of Camelback, 6' BGS	12:45	0	0	20.8	4.75	0.76
(45) Signal Box, at Intersection of Camelback and First, Southwest Corner, Between Signal Lights	12:51	0	0	20.9	4.56	0.14

Photo 5: Water service on Camelback (locations 43 and 44)

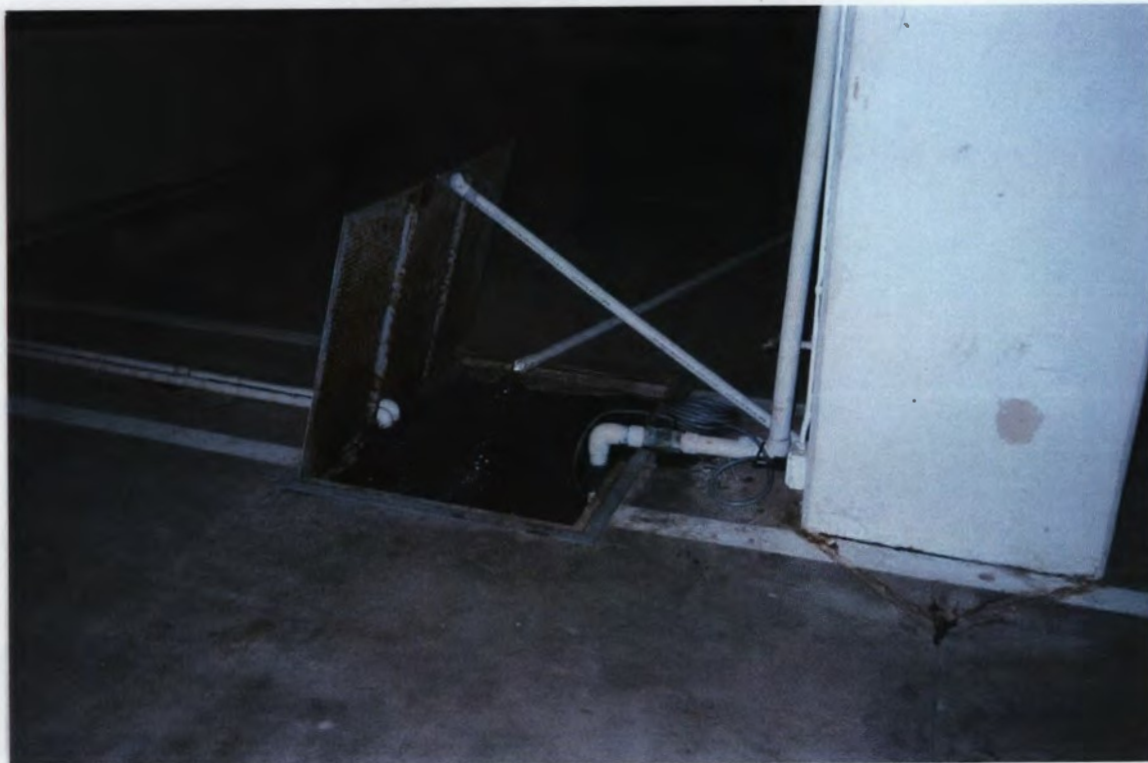
(48) Subterranean Parking Garage, One Camelback, Sump #3	13:00	8	5	20.3	834	333
(49) Subterranean Parking Garage, One Camelback, Sump #2	13:09	4	2	20.8	17.18	9.25

Photo 6: Sump #3, in basement of One Camelback (location 48)

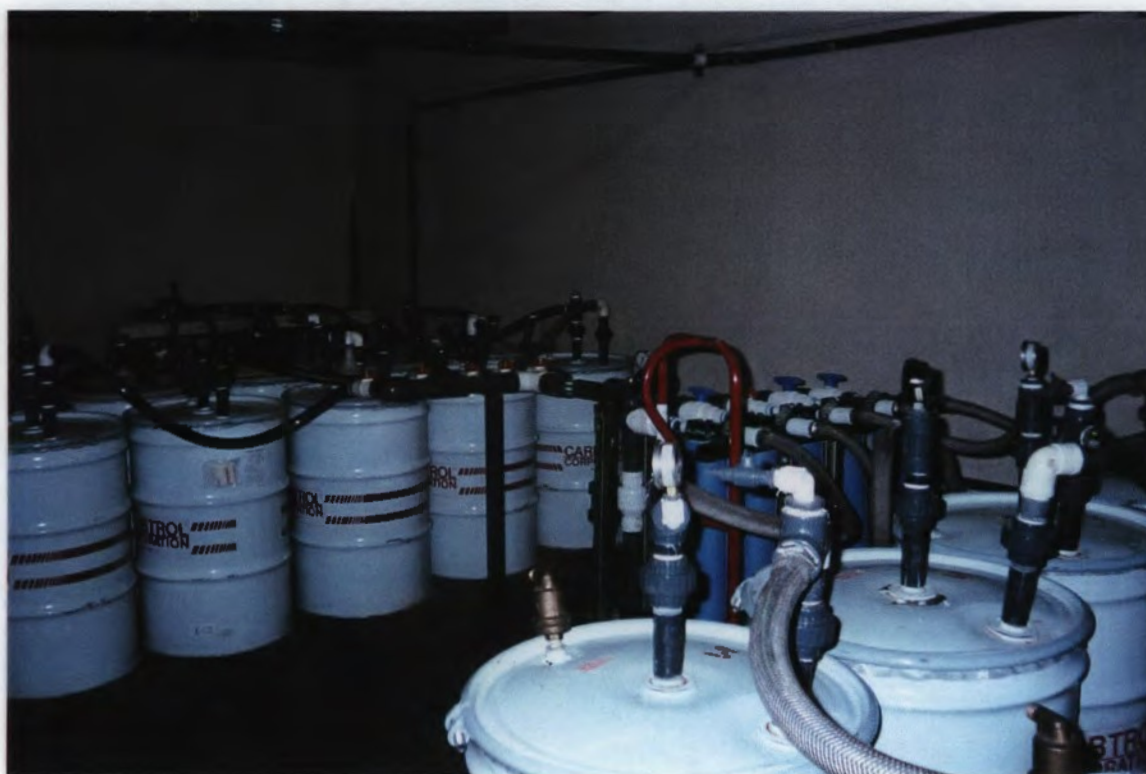
(50) Subterranean Parking Garage, One Camelback, Treatment Room	13:12	0	4	21.0	8.00	1.76
(51) Subterranean Parking Garage, One Camelback, Sump #1	13:12	12	4	20.7	1400	150

Photo 7: Carbon filter treatment system in basement (location 51)
